JARBIDGE RIVER STREAM CHANNEL INTEGRITY INVENTORY

Elko County, Nevada

Humboldt-Toiyabe National Forest
2035 Last Chance Road
Elko Nevada 89801
(Contract 53-0261-01-08, Task Order SWINAO-4)

February 2002

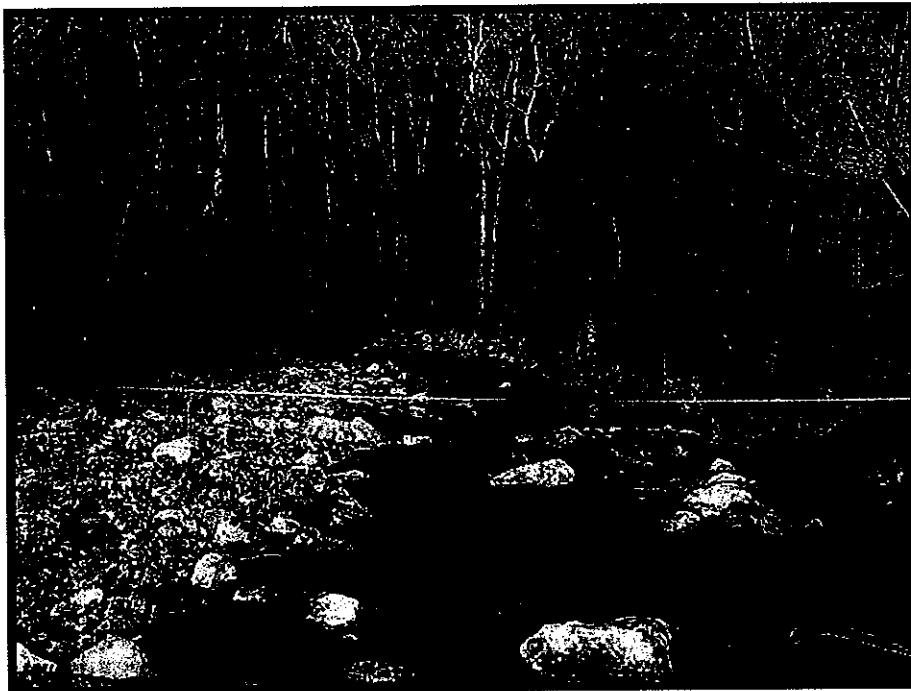
Photo 2-8, looking downstream toward Pine Creek Campground. Stable section with good bankfull indicators. Map Plate 1a Location: W-32

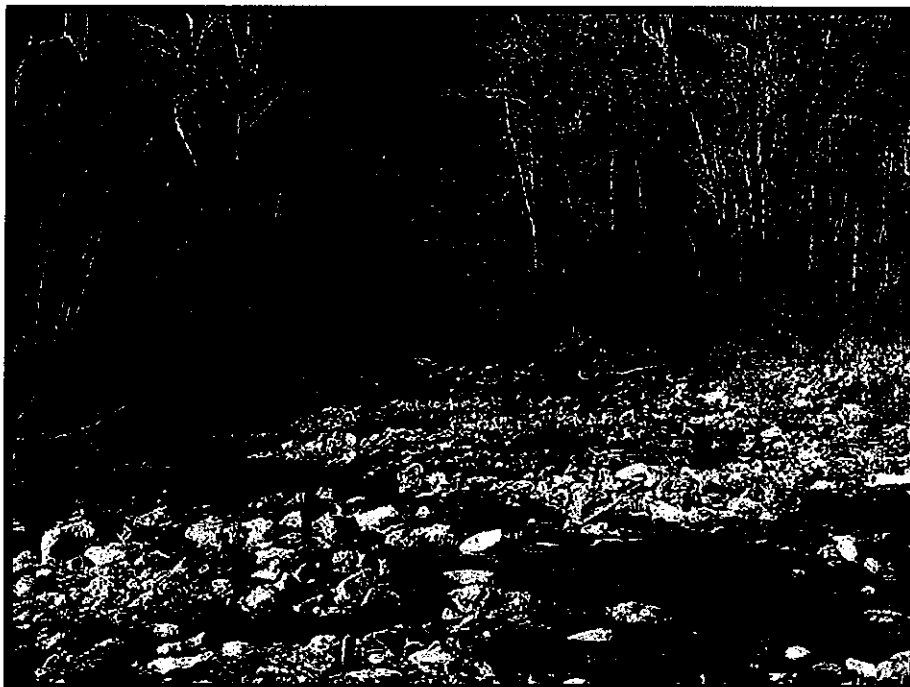
Photo 2-14, looking downstream. In channel depositional zone, high width/depth ratio reach. Map Plate 1a Location: W-42

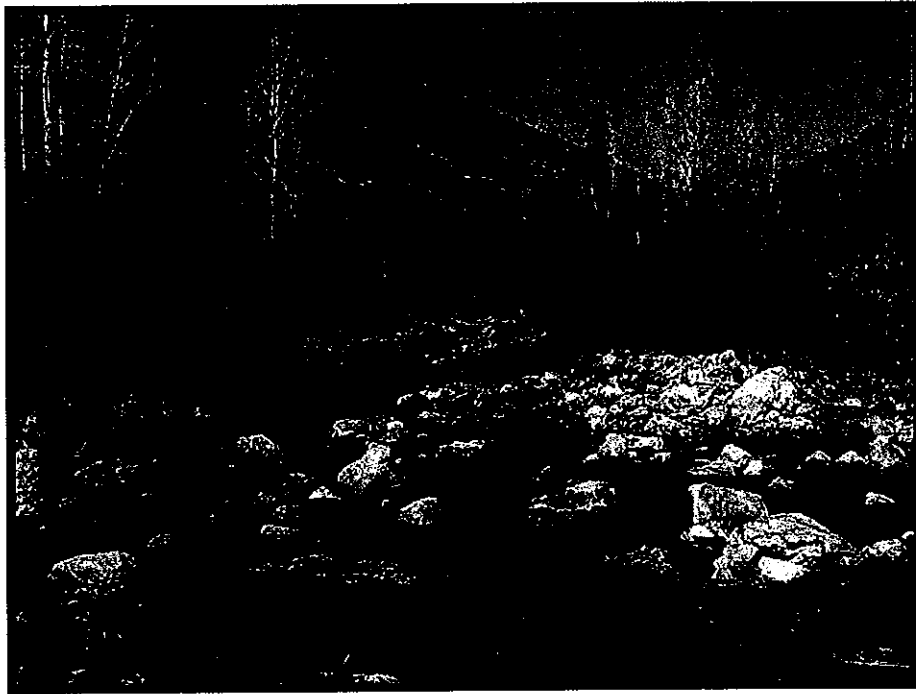
Photo 2-15, looking downstream. Channel bounded by fluvial sediments. Map Plate 1a
Location: W-44

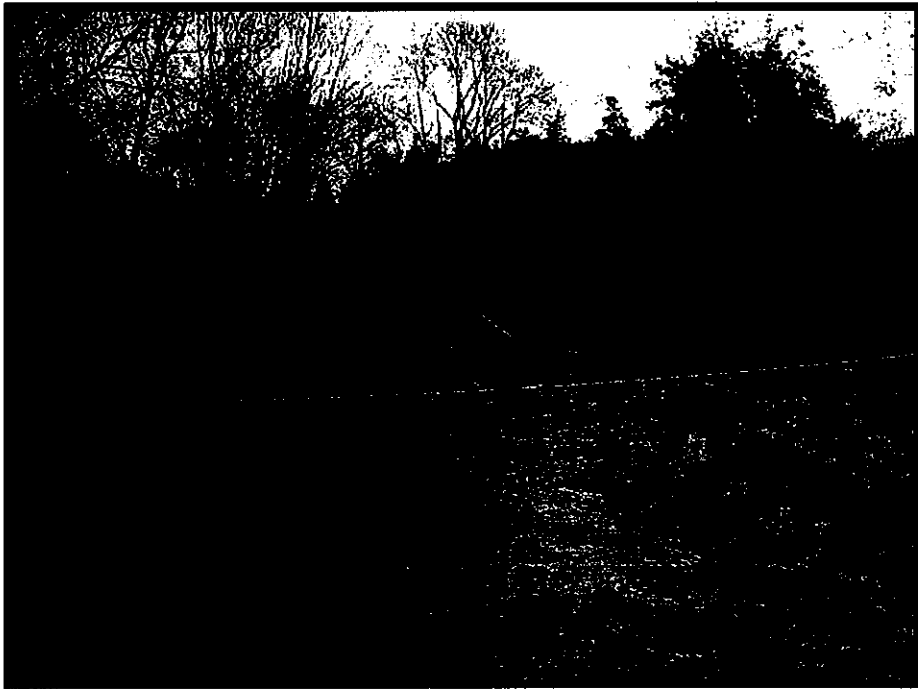
Photo 2-22, looking downstream. Good bankfull indicators at section. Map Plate 1a Location:
W-56

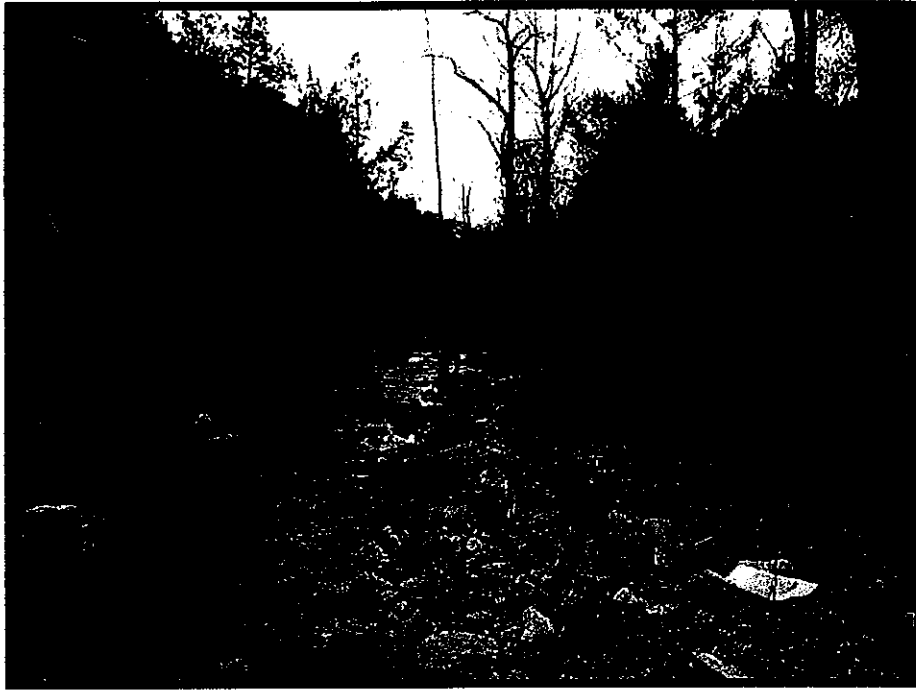
Photo 2-23, looking downstream. Six to 12 inch diameter Fremont cottonwoods on terrace surface ~ 8 feet above bed of active channel. Map Plate 1a Location: W-58

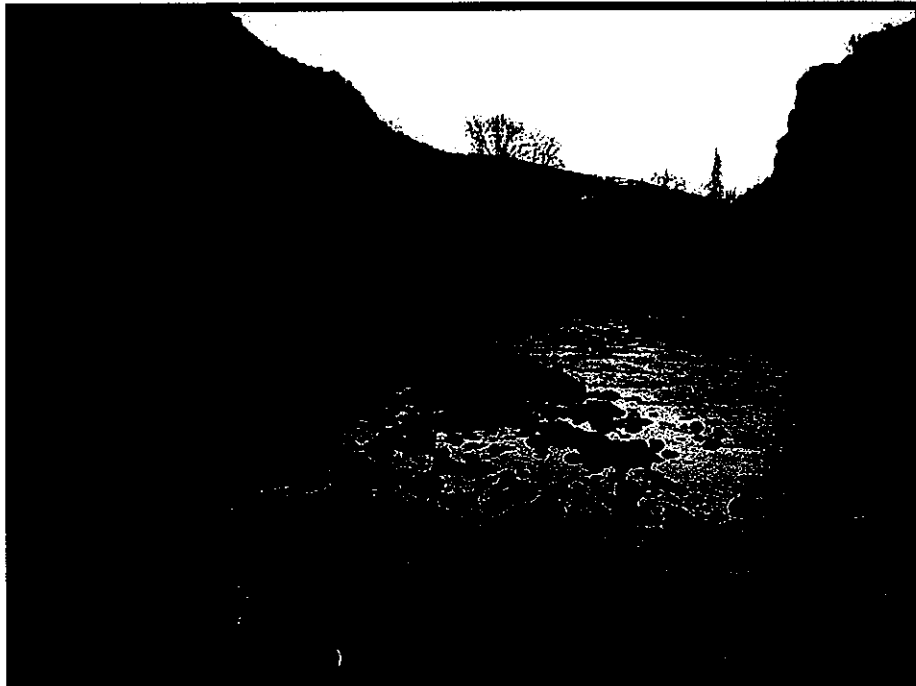
Photo 2-24, looking downstream. Bedrock on channel margins. Map Plate 1a Location: W-60

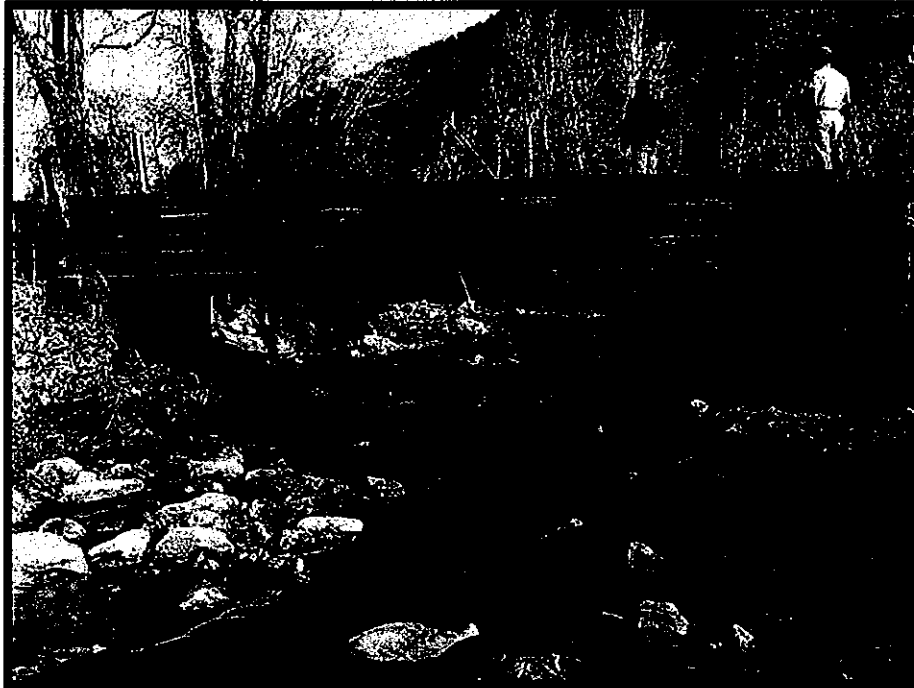
Photo B-11, looking downstream. Site location Br-5. Note gabions at left abutment.

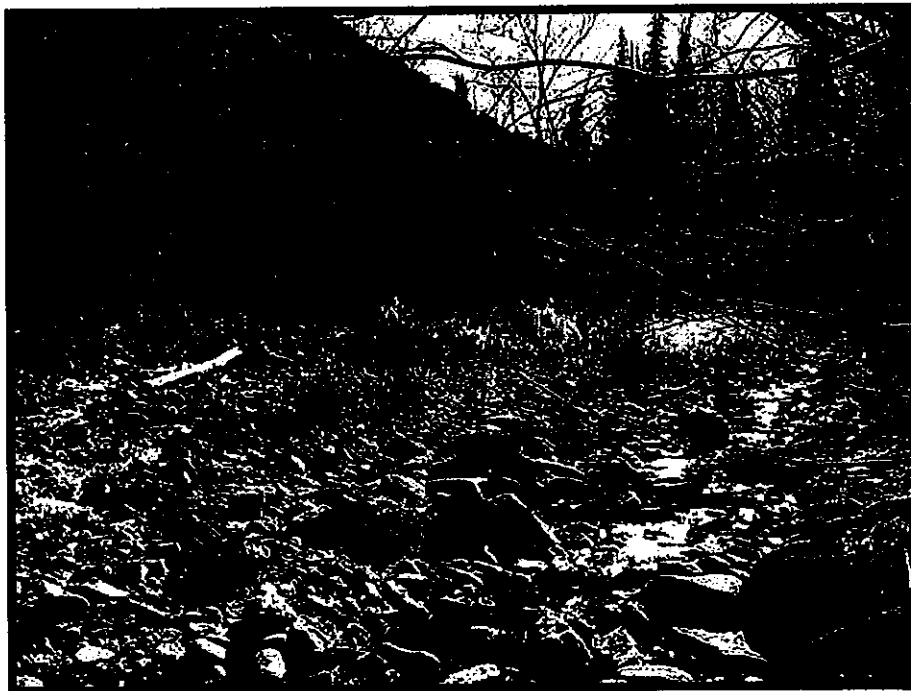
Photo R-2, looking downstream in lower part Pine Creek Campground. Campground road encroaching on channel in lower right part of photo. Map Plate 4a Location: R-2

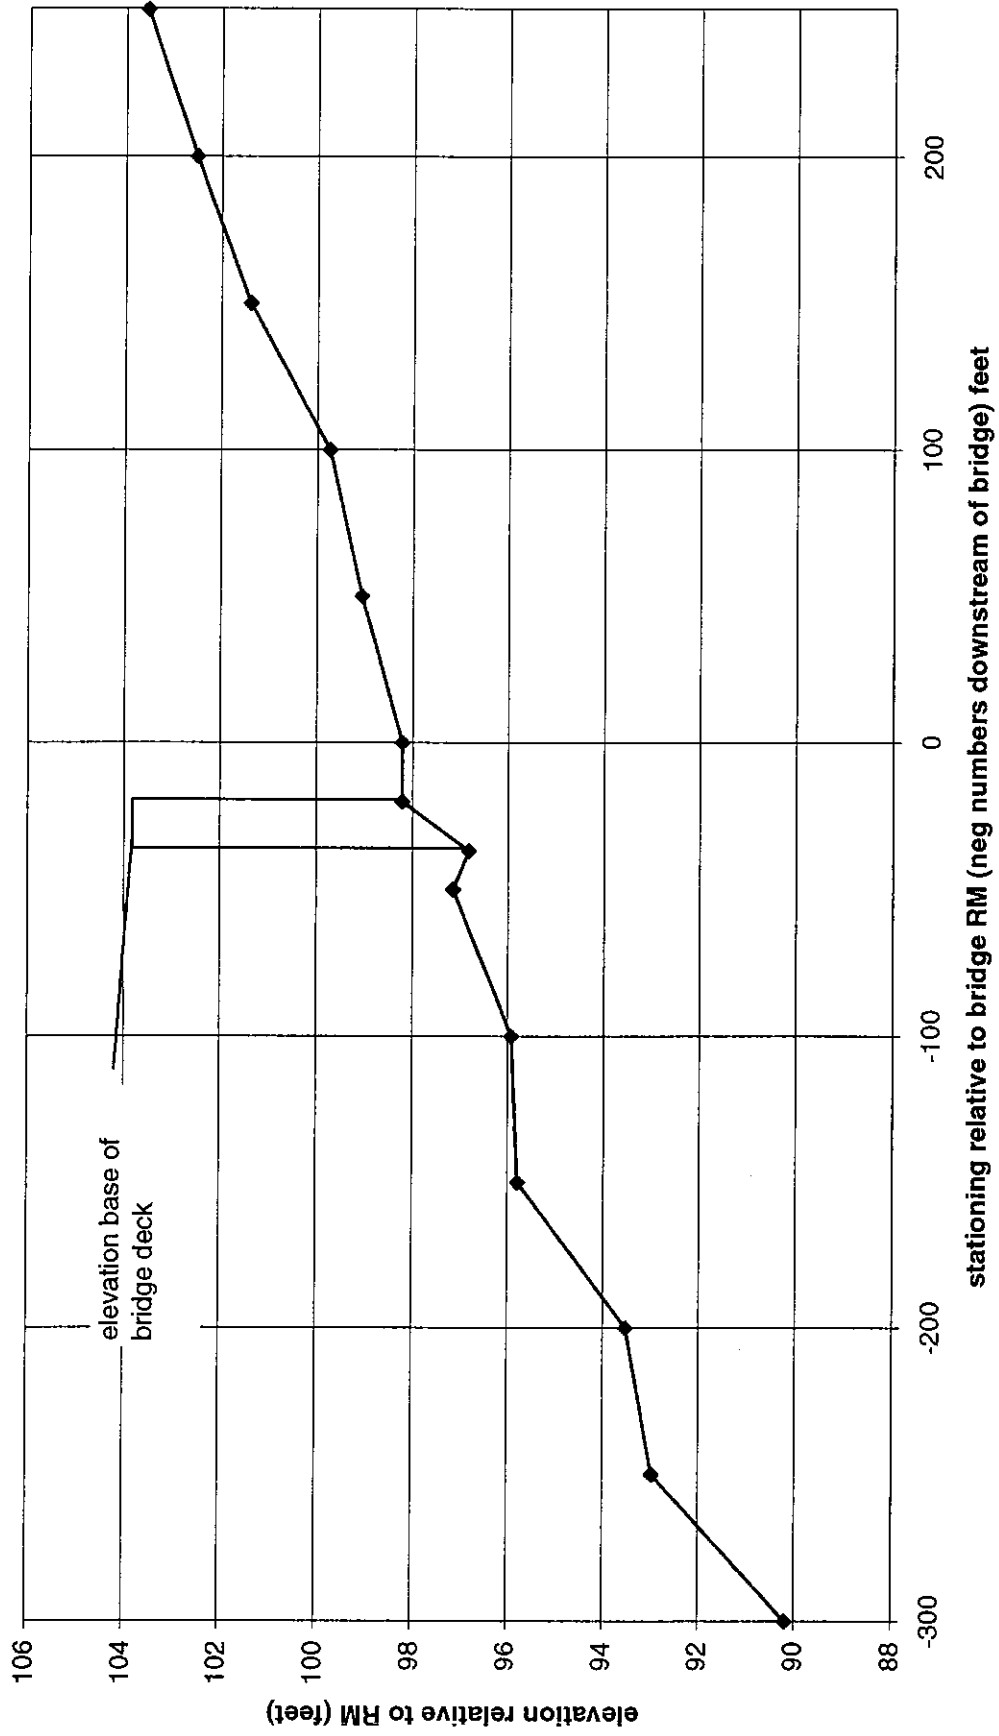
Bridge Br6495T (Br-5)
Bed surface profile

upstream	bridge	downstream	width	width	width	24.2'	18'	22.4'			21'
upstream	bridge	downstream											
width	width	width											
24.2'	18'	22.4'											
		21'

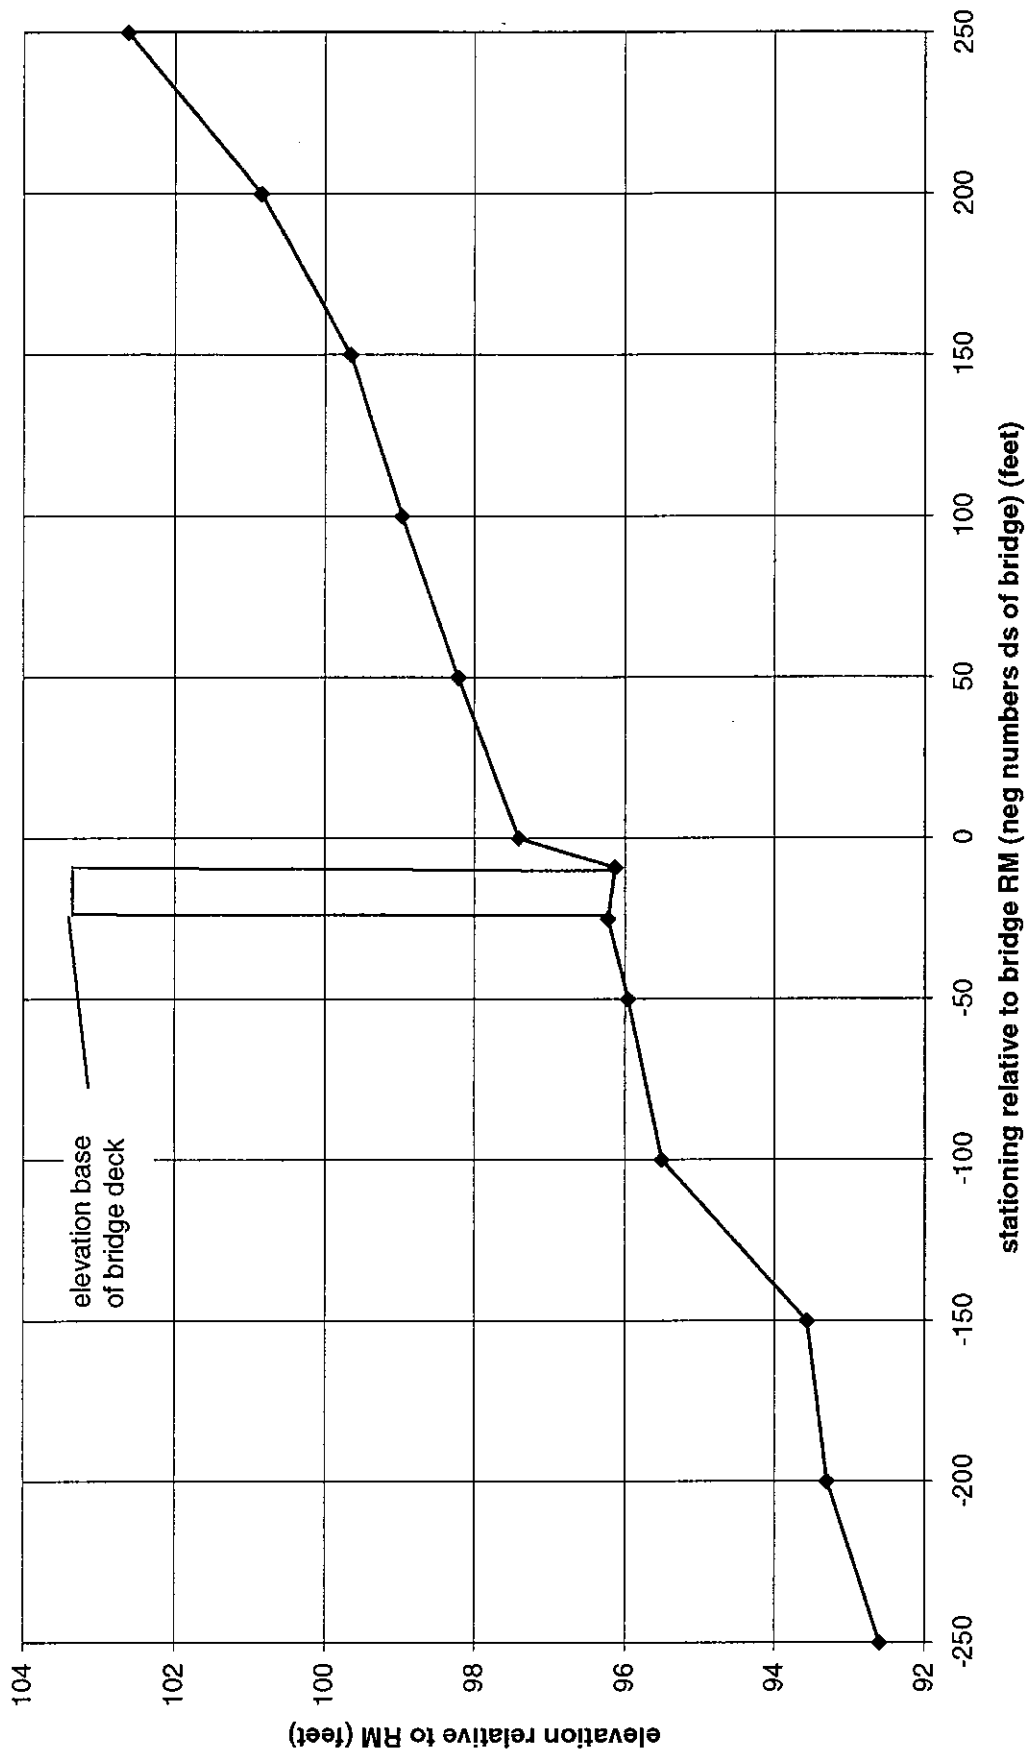
Bridge Br6462T (Br-6)
Bed surface profile

<u>Bridge Number</u>	Br 6462T												
<u>Bridge Opening</u>	29.7 feet wide, 8.6 feet high No intermediate piers												
<u>Upstream Conditions</u>													
<u>Channel</u>	Uniform straight run upstream of bridge Cobble through gravel substrate Profile data and photos suggest small sediment lobe deposited - upstream of bridge opening Bridge section may influence channel planform patterns - but downstream Bonanza Gulch debris fan is primary planform control												
<u>Floodplain</u>	Road approaches constrict flood flows to bridge opening Active channel has limited access to floodplain												
<u>Debris</u>	No debris blockage observed												
<u>Bridge Section</u>	Limited erosion on upstream wingwalls Local scour on right abutment Scour through bridge section Road approaches may restrict lateral expansion of flood flows Bridge has good conveyance characteristics												
<u>Downstream Conditions</u>													
<u>Channel</u>	Historic dredging downstream of bridge - may have influence on bed profile Uniform run Cobble through gravel substrate Active channel does not have access to floodplain												
<u>Summary</u>	Bridge located in downstream part of disturbed and adjusting reach and - upstream of river reach inset into Bonanza Gulch Fan Bridge is channel constriction and effective flow area and floodplain- constriction may increase stream power in exit section

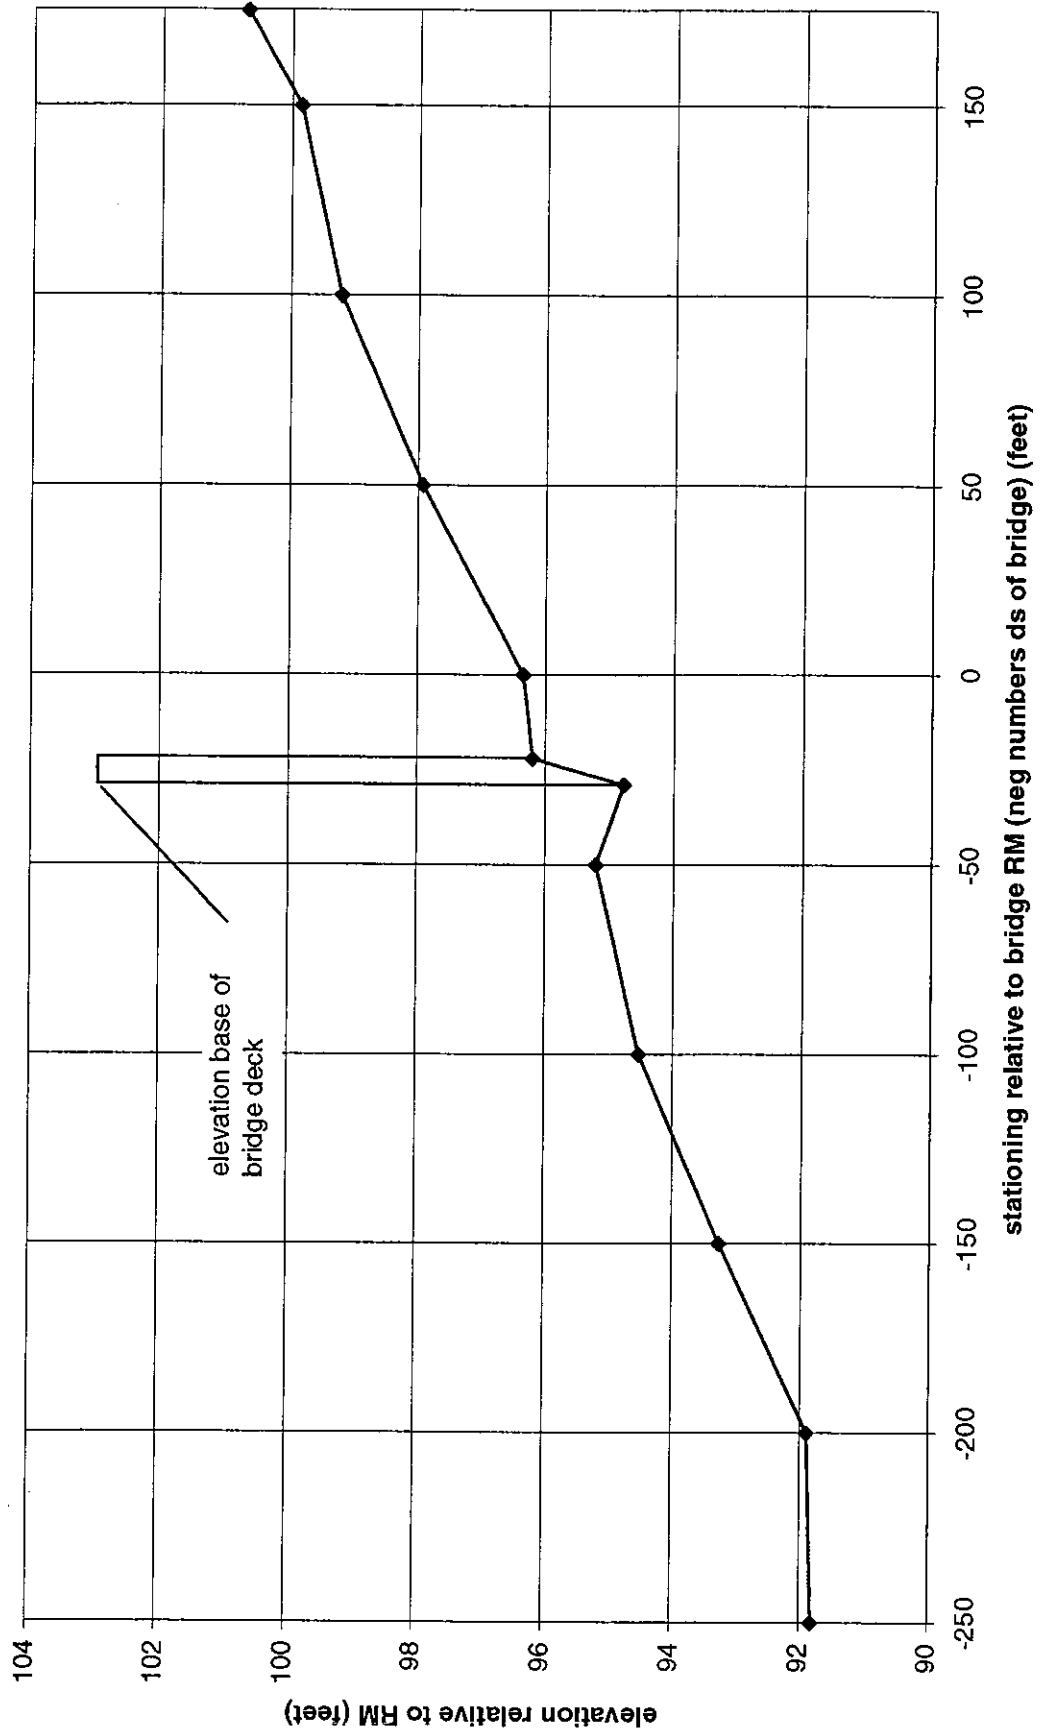
Bridge Br6396T (Br-7)
Bed surface profile

<u>Bridge Number</u>	Br 6396T
<u>Bridge Opening</u>	28 feet wide, 6.9 feet high maximum height BS to base of bridge deck 9.4 feet No intermediate piers
<u>Upstream Conditions</u>	
<u>Channel</u>	Bridge located in cross over between meander bends Coarse substrate - boulder through gravel No active erosion upstream of bridge - left edge of channel - has bedrock on margin
<u>Floodplain</u>	Right side approach road cuts across accessible valley width - road will constrict flood flows which inundate floodplain Channel currently has limited access to floodplain
<u>Debris</u>	No debris blockage observed
<u>Bridge Section</u>	Bridge has poor alignment and potential for debris blockage exists Bridge has poor alignment - large contraction losses upstream due to channel bend Local scour on left abutment Deposition on right abutment Profile suggests contraction scour through bridge section Bridge does force channel to maintain current planform - but well developed meander exists up and downstream of bridge section

<u>Downstream Conditions</u>	Uniform run downstream of bridge Cobble through gravel substrate Bank erosion not observed - well developed riparian vegetation
<u>Summary</u>	Approach road constricts floodplain inundating flows Road has locally poor alignment upstream Contraction scour through bridge section Bridge not clearly flow area constriction, but bridge + right approach road are - high flow constriction upstream bridge downstream widths width width 25' 28' 28' 24'

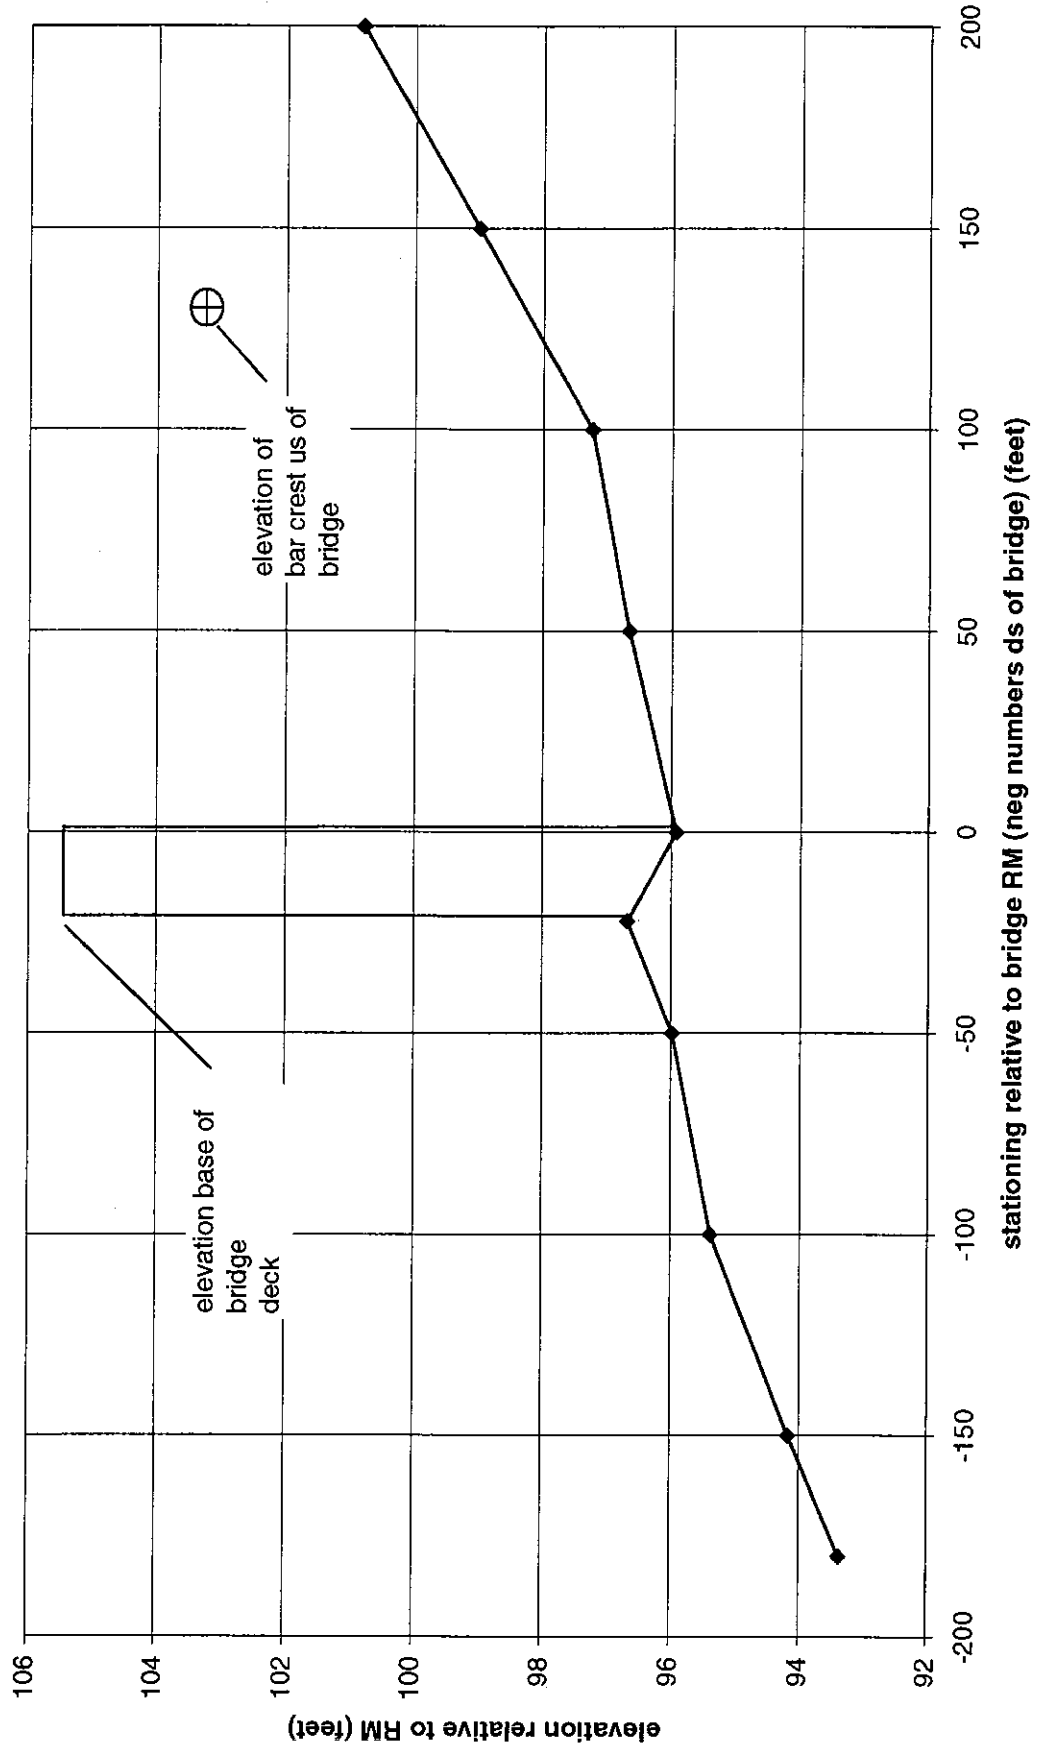
Bridge Br6304T (Br-8) Bed surface profile

<u>Bridge Number</u>	Br 6304T														
<u>Bridge Opening</u>	bridge width 29 feet, bridge height 9.9 feet bridge width perpendicular to flow 26 feet No intermediate piers														
<u>Upstream Conditions</u>															
<u>Channel</u>	Bridge located in cross over between restricted meanders Bridge located in reach with reduced valley width and - segments of road encroachment on active channel Cobble through gravel substrate Large depositional bar upstream on right channel margin Bridge has poor alignment - combination of alignment, flow area constriction, and upstream sediment sources cause deposition On left margin 220' by 4' high cut slope in terrace slope - cut slope appears related to deposition and migration to left channel margin														
<u>Floodplain</u>	Left road approach restricting flood flow access to floodplain Active channel has limited access to floodplain														
<u>Debris</u>	No debris blockage observed Potential for debris accumulation exists due to poor upstream alignment														
<u>Bridge Section</u>	Scour not observed on abutments Potentially large contraction losses due to poor approach alignment Overall depositional reach at bridge														
<u>Downstream Conditions</u>	Uniform run downstream of bridge Small boulder to cobble substrate 80 feet of actively eroding bank on right edge - appears related to increased stream power downstream of bridge section Channel area may have been historically dredged														
<u>Summary</u>	Bridge not clearly identified as width constriction Bridge + approach road appear to be constriction during floodplain - inundating flows

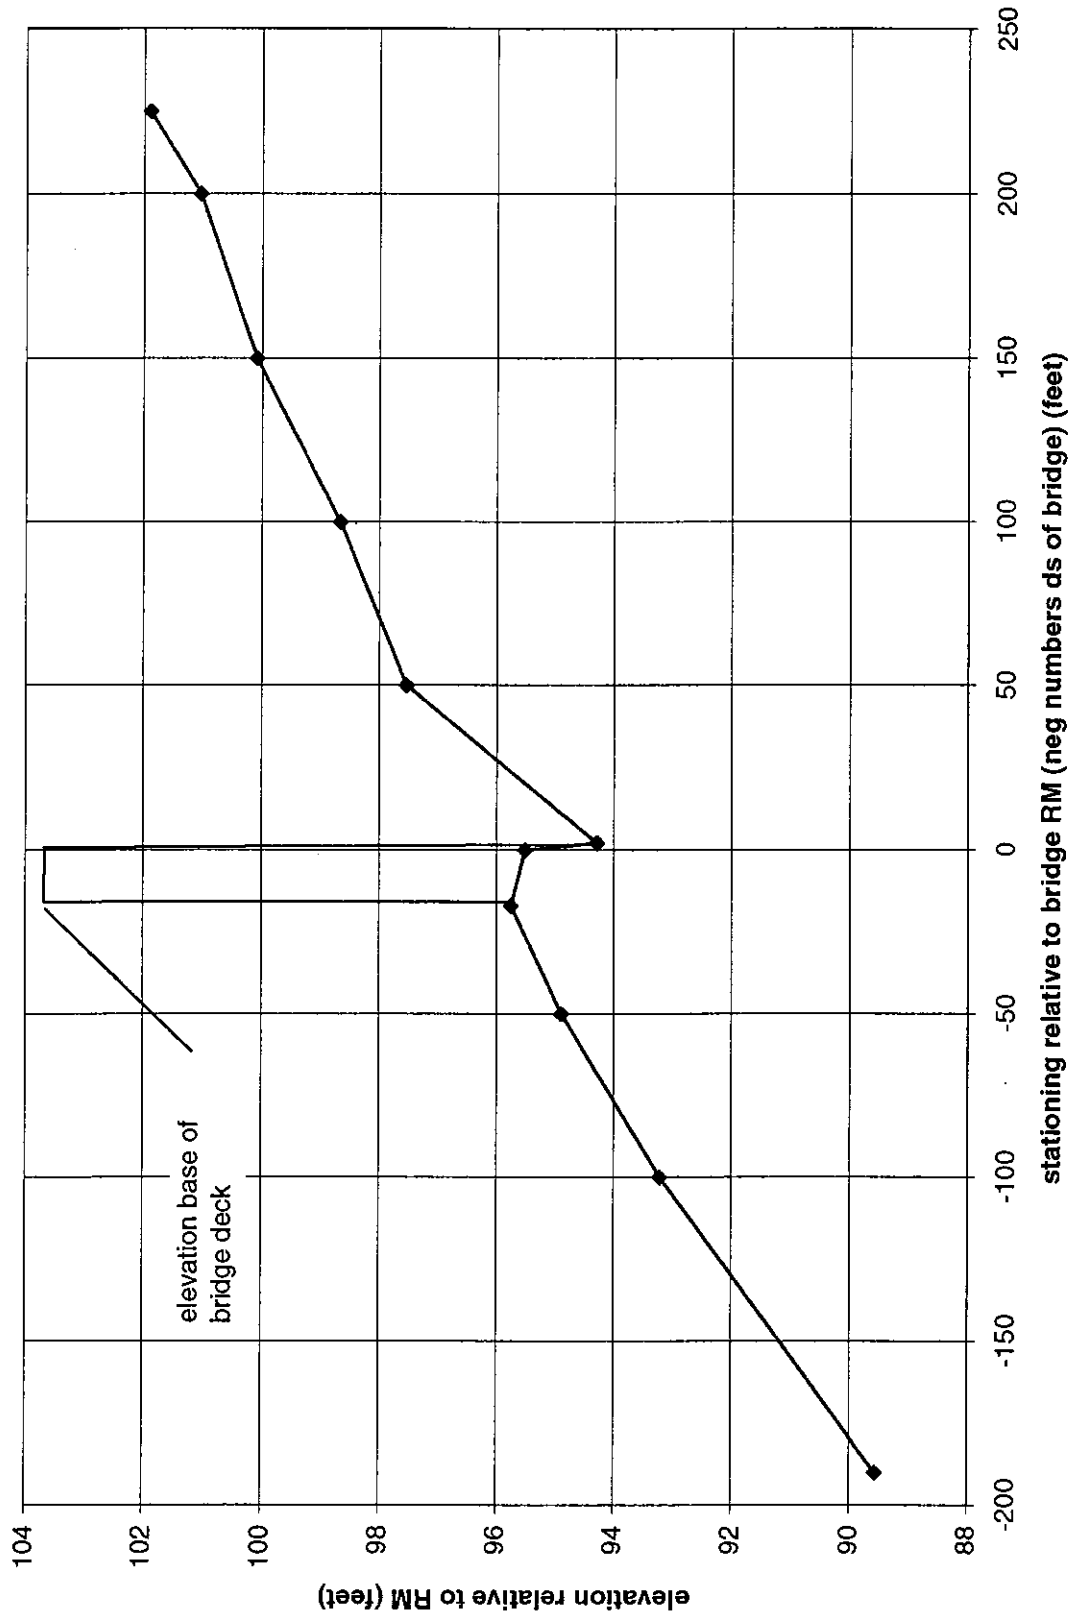
Bridge Br6236T (Br-7)
Bed surface profile

<u>Bridge Number</u>	Br 6236T											
<u>Bridge Opening</u>	bridge 9.6 feet high, width estimate 28 feet No intermediate piers											
<u>Upstream Conditions</u>												
<u>Channel</u>	Channel flowing through toe of debris fan area Historic disturbance footprint from mining and townsite development Channel confined within debris fan sediments Bridge located on downstream axis of meander bend which is migrating to left valley edge Small boulder through cobble substrate Profile indicated bed degradation for 50 feet upstream of bridge											
<u>Floodplain</u>	Channel has limited access to floodplain - flowing through toe of fan											
<u>Debris</u>	No debris blockage observed Potential for debris blockage exists due to poor bridge alignment											
<u>Bridge Section</u>	Abutment scour not observed Profile indicates there may be contraction scour through bridge section Bridge has poor upstream alignment - may lead to large contraction losses Left wingwall failing - miscellaneous fill placed there											
<u>Downstream Conditions</u>	Cobble through gravel substrate Large continuous cutslope downstream of bridge Cutslope over 13 feet in height Appears erosion due to combination of processes - Debris fan inputs, historic mining and townsite impact, and increased stream power - downstream of bridge section											
<u>Summary</u>	Bridge has poor alignment Contraction scour probable Bridge wingwalls failing Combination of bridge opening and alignment appear to reduce channel flow area

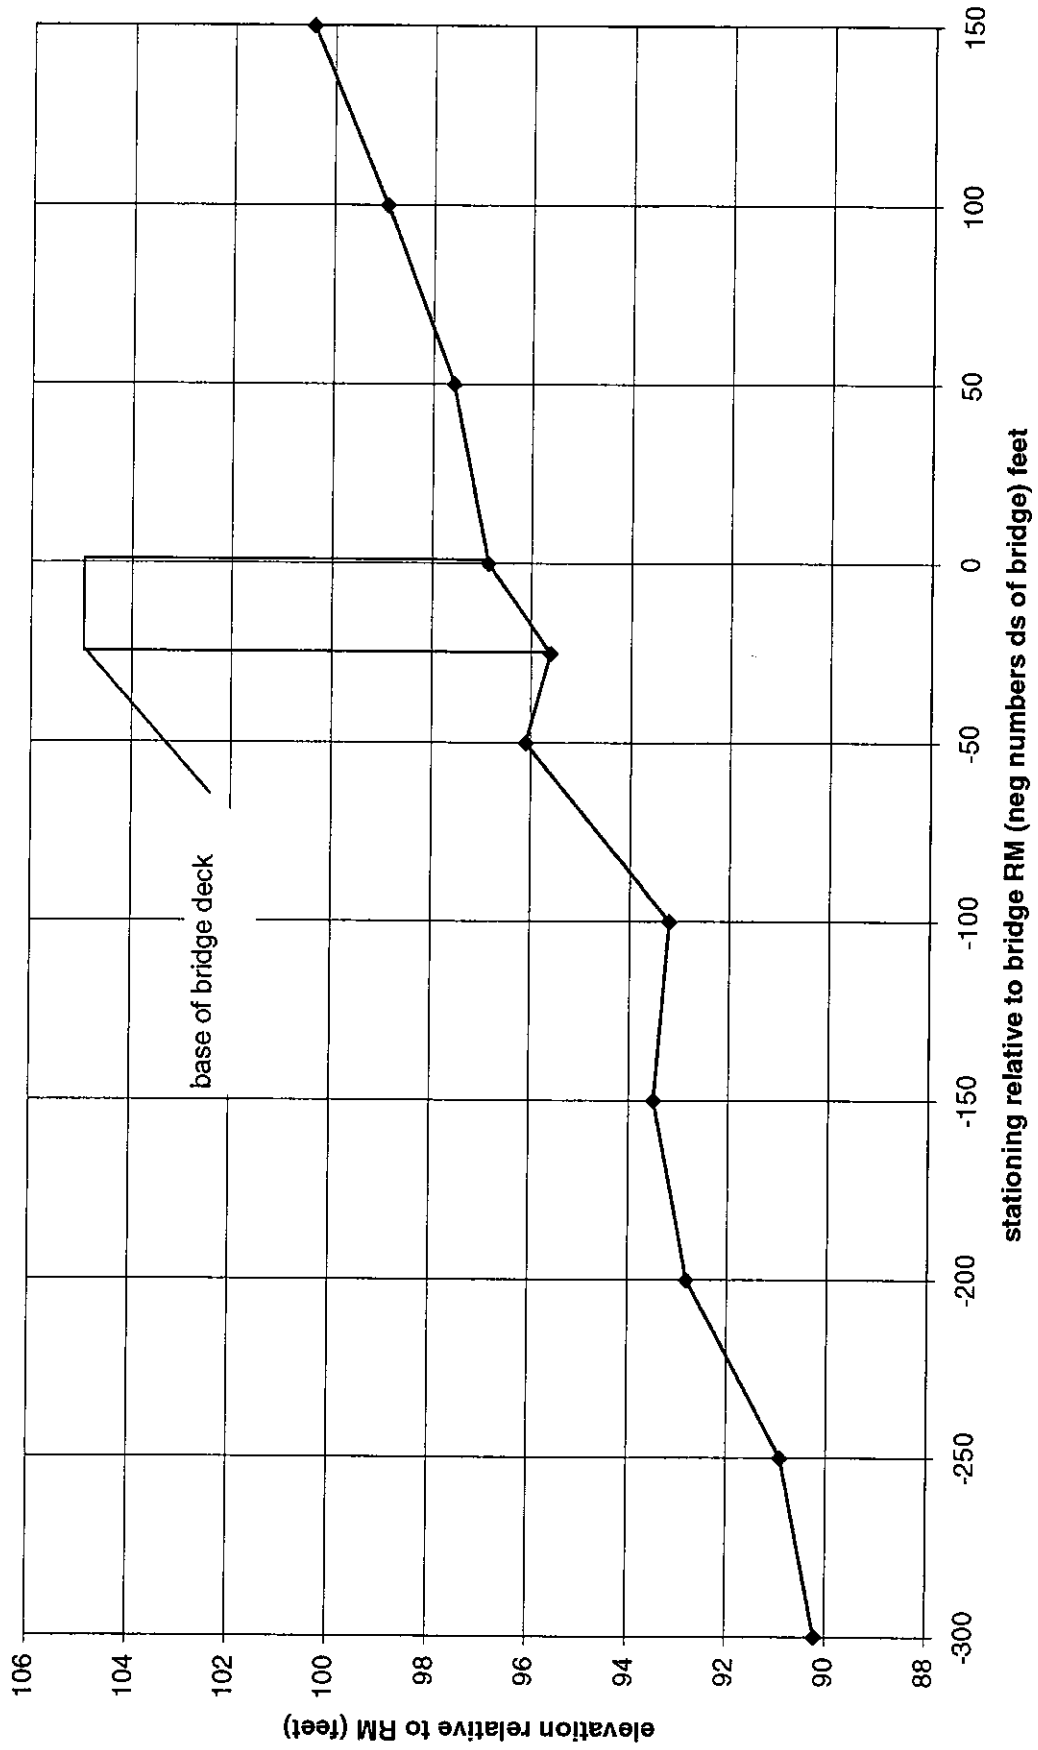
Bridge Br6162T (Br-10) Bed surface profile

<u>Bridge Number</u>	Br 6162T		
<u>Bridge Opening</u>	Bridge width 28.8 feet, bridge height 7.8 feet No intermediate piers		
<u>Upstream Conditions</u>			
<u>Channel</u>	Highly disturbed reach - historic wasterock and mill tailings in floodplain, recent dredging Straight reach through bridge section Cobble substrate Limited riparian vegetation		
<u>Floodplain</u>	Wide potentially accessible valley width, but historic activity has eliminated channel access to floodplain		
<u>Debris</u>	No debris blockage observed		
<u>Bridge Section</u>	Local scour on right abutment Bridge has good alignment and conveyance characteristics No ponding observed on upstream end		
<u>Downstream Conditions</u>	Highly disturbed reach - historic wasterock and mill tailings in floodplain, recent dredging Gabion walls on right edge of water Cobble substrate		
<u>Summary</u>	Potential influence of bridge masked by other disturbances

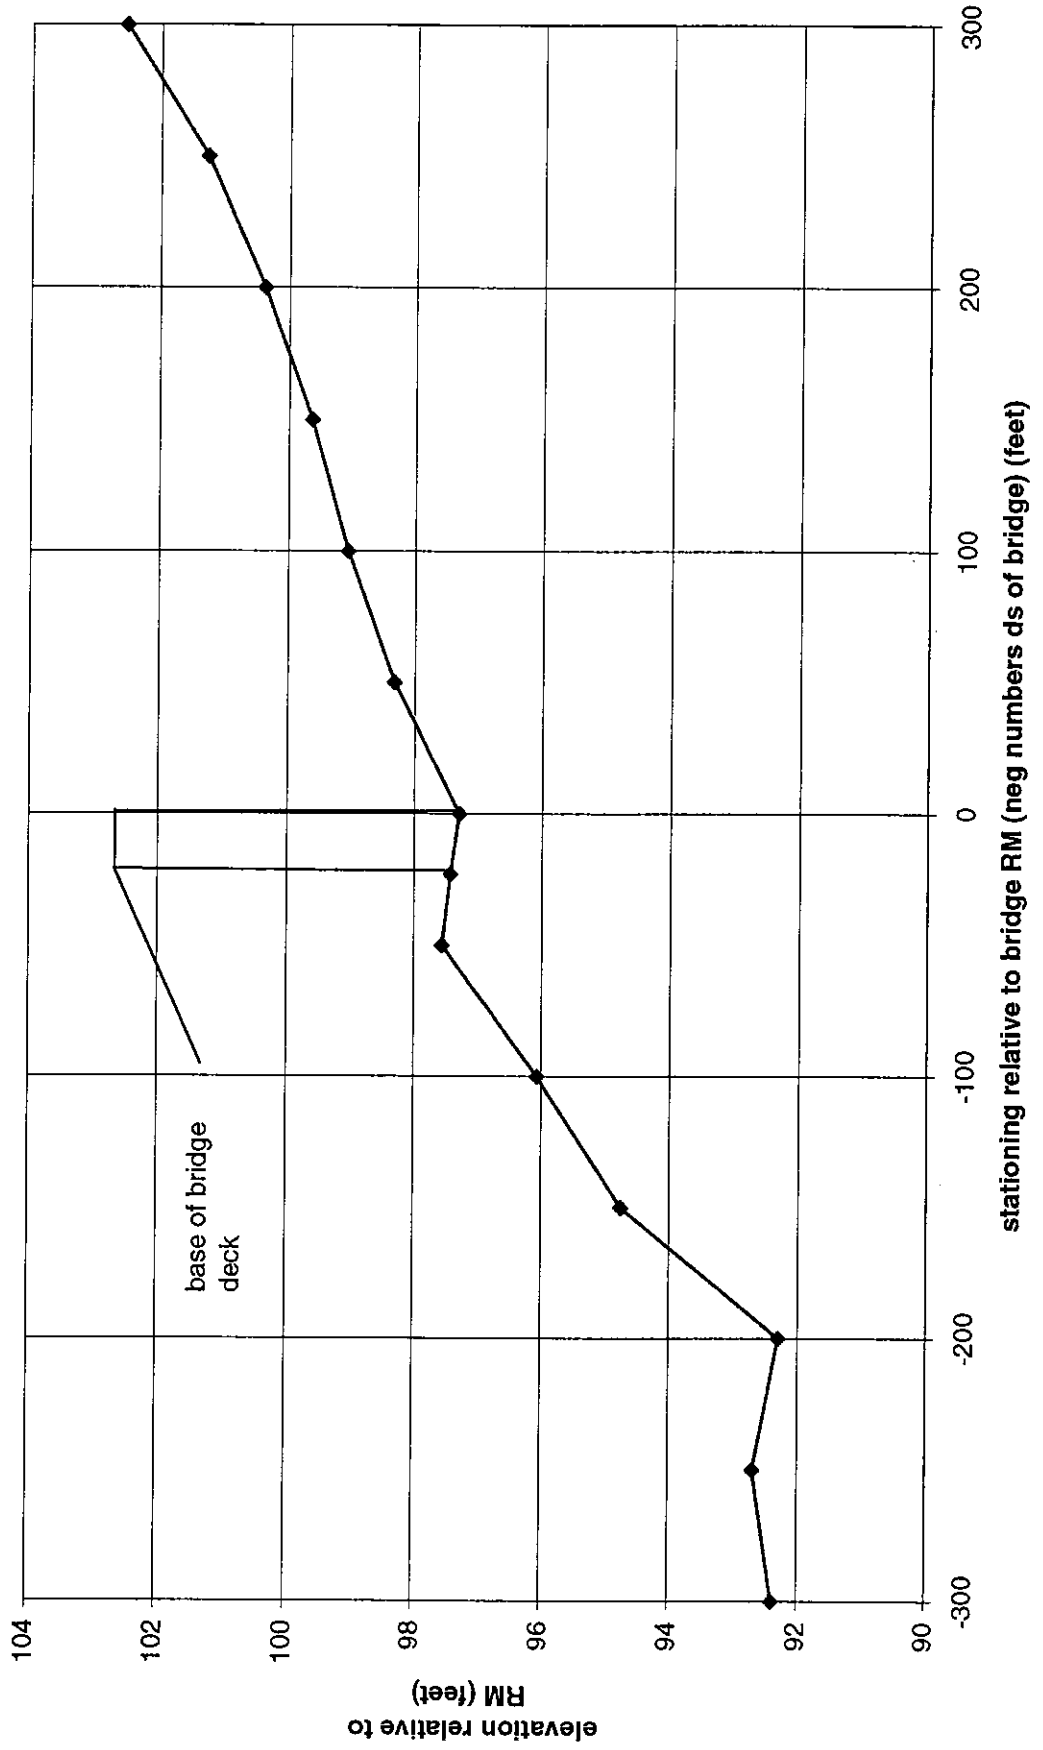
Bridge USGS_Gage (Br-11) Bed profile survey

<u>Bridge Number</u>	Br USGS-Gage - vicinity of Mahoney Guard Station		
<u>Bridge Opening</u>	Bridge height 5.5 feet, bridge width 39 feet No intermediate piers		
<u>Upstream conditions</u>			
<u>Channel</u>	Overall depositional and locally braided reach Straight channel through bridge reach Channel has been recently dredged up and downstream of bridge Cobble substrate Do not observe sediment deposition or ponding upstream of bridge		
<u>Floodplain</u>	In large flood flows, floodplain will be inundated Low and intermediate flood flows, right approach road and dredging will - reduce overbank flows		
<u>Debris</u>	No debris blockage observed		
<u>Bridge Section</u>	Depositional reach - do not observe scour at abutments Bridge has good conveyance characteristics Bridge controls local channel planform		
<u>Downstream Conditions</u>	Depositional reach - do not observe bank erosion Increase in slope downstream of bridge (profile) may be related to - bridge control on channel planform, decrease in sinuosity, and increase in slope Cobble substrate

<u>Summary</u>	Depositional reach Bridge is locally controlling channel alignment		
	upstream widths	bridge width	downstream widths
	72'	39'	25'
	32'		24'
